## APPENDIX 7

### EVALUATION OF CODE SECTION 14 CCR 916.4(A) [936.4(A), 956.4(A)] RELATIVE TO “THP MINING”

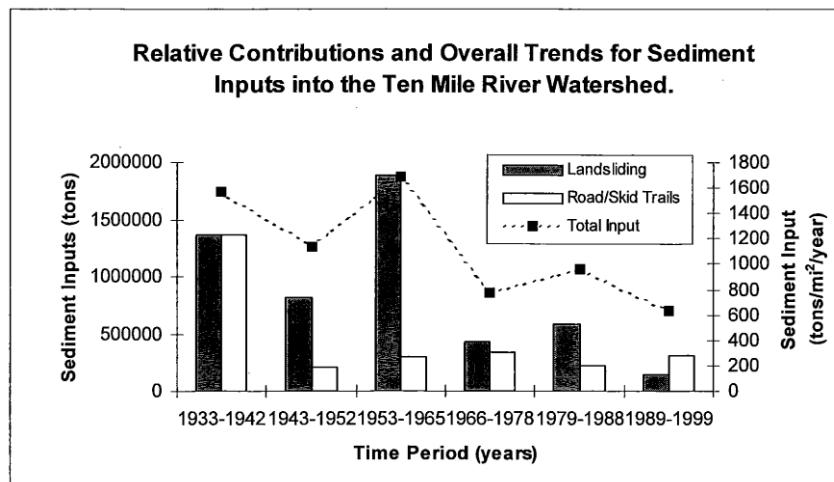
- Graphs – Section IV of THP 1-15-107 MEN (page 154):

The downward trend in sediment inputs from landsliding corresponds to the implementation of the Forest Practice Rules.

The same graph is found in THPs 1-15-094 MEN (page 160), 1-14-126 MEN (page 173), 1-13-031 MEN (page 257), 1-10-033 MEN (page 206), 1-09-022 MEN (page 223), 1-08-015 MEN (page 284) and 1-17-036 MEN (page 407).

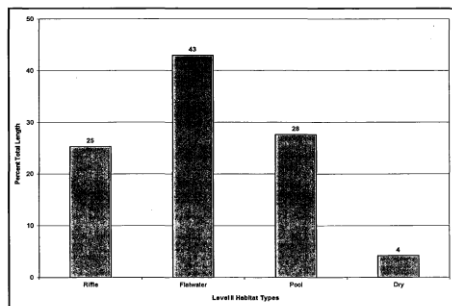
Figure 1: Level II habitat types by percent total length in Smith Creek adjacent to the Dutchman West THP, 2015.

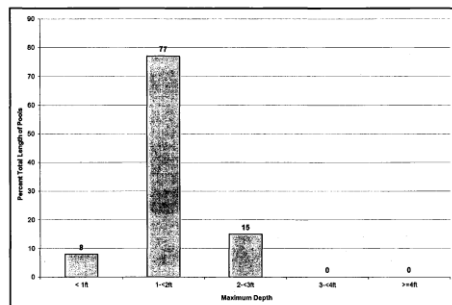
Figure 2: Maximum depth of pools in Smith Creek adjacent to the Dutchman West THP, 2015.

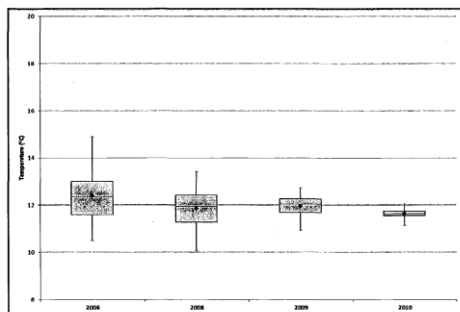
Figure 7: Boxplot interquartile distributions for the seven-day rolling average temperatures for SFT41 in Smith Creek (2006, 2008, 2009 & 2010) downstream of the Dutchman West THP, 2015. Black diamonds indicate averages and lines indicate medians.

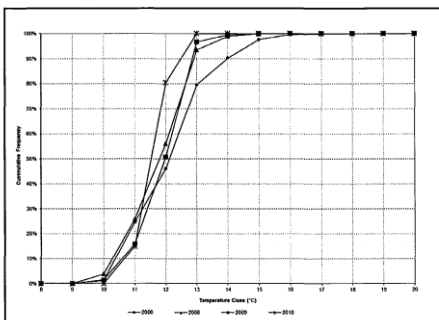
Figure 8: Cumulative Frequency Plot of Temperature Exceedence for the SFT41 monitoring site in Smith Creek (2006, 2008, 2009 & 2010) downstream of the Dutchman West THP, 2015.

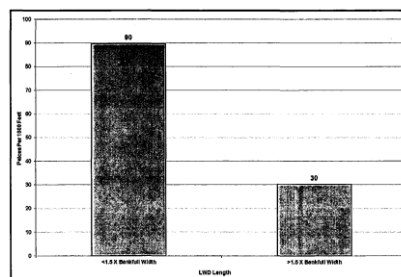
Figure 5: Pieces of Large Woody Debris (LWD) per 1000 feet of stream surveyed in Smith Creek adjacent to the Dutchman West THP, 2015.

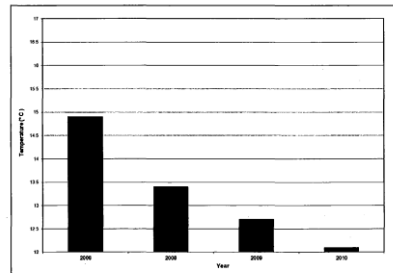
Figure 6: Maximum Weekly Average Temperatures (MWAT) for the SFT41 monitoring site in Smith Creek (2006, 2008, 2009 & 2010) downstream of the Dutchman West THP, 2015.

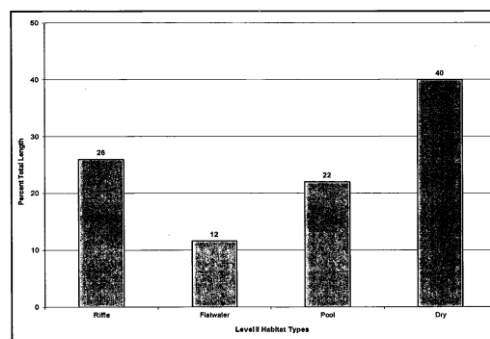
Figure 9: Level II habitat types by percent total length in Unnamed Tributary A downstream of the Dutchman West THP, 2015.

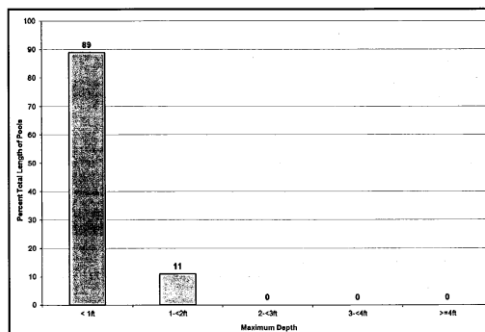
Figure 10: Maximum depth of pools in Unnamed Tributary A downstream of the Dutchman West THP, 2015.

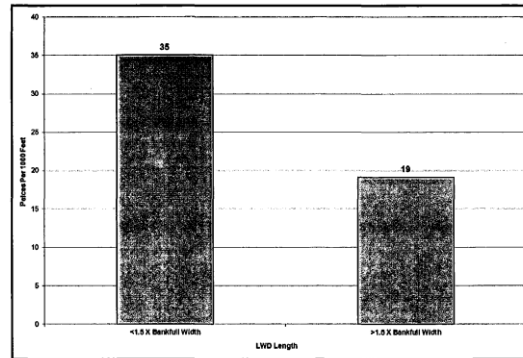
Figure 13: Pieces of Large Woody Debris (LWD) per 1000 feet of stream surveyed in Unnamed Tributary A downstream of the Dutchman West THP, 2015.

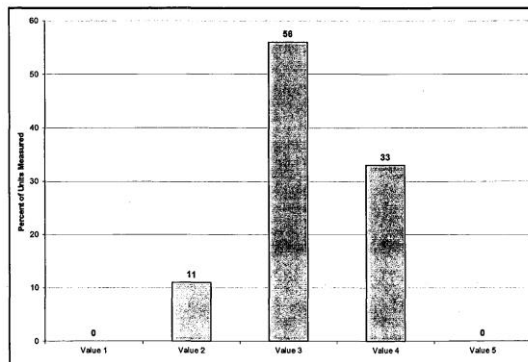
Figure 12: Embeddedness Values in Unnamed Tributary A downstream of the Dutchman West THP, 2015.

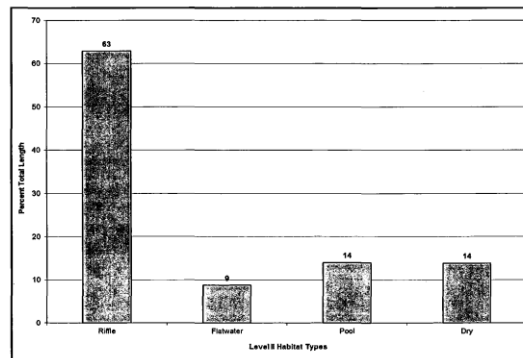
Figure 14: Level II habitat types by percent total length in upper Campbell Creek downstream of the Dutchman West THP, 2015.
